RATTLE BROOK BRIDGE

FRP Re-Bar

The Problem:

ARROW PROJECT PROFILE

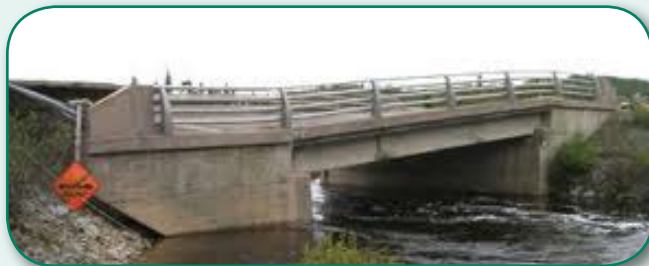
After being severely damaged by Hurricane Igor in September 2010, the Rattle Brook Bridge was in need of a major rehabilitation, deck and barrier walls.

Rattle Brook Bridge - Damaged by Hurricane Igor

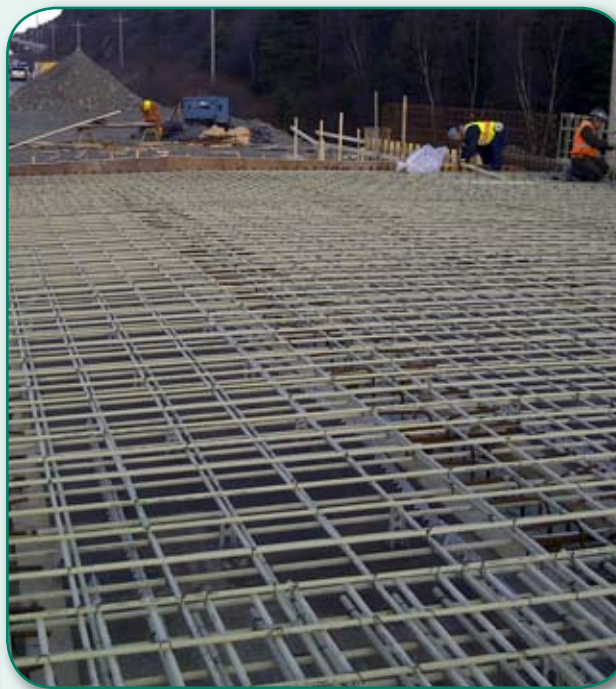
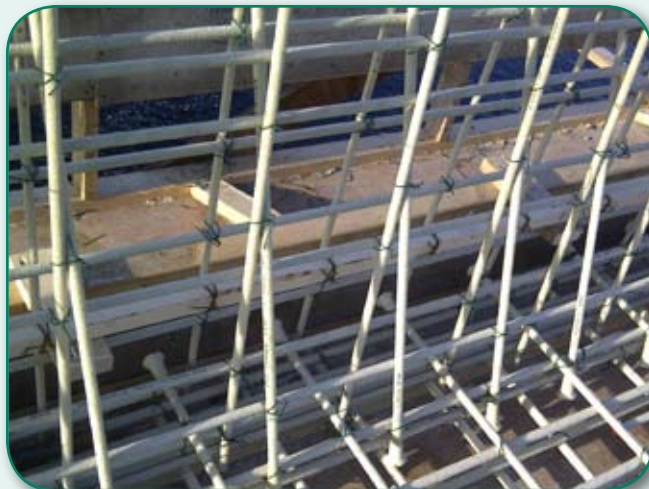
#4, #5, and #6 V-ROD HM GFRP bars were used in this project. A total of 6,000 meters of straight V-Rod was installed, including bars with anchoring heads.
